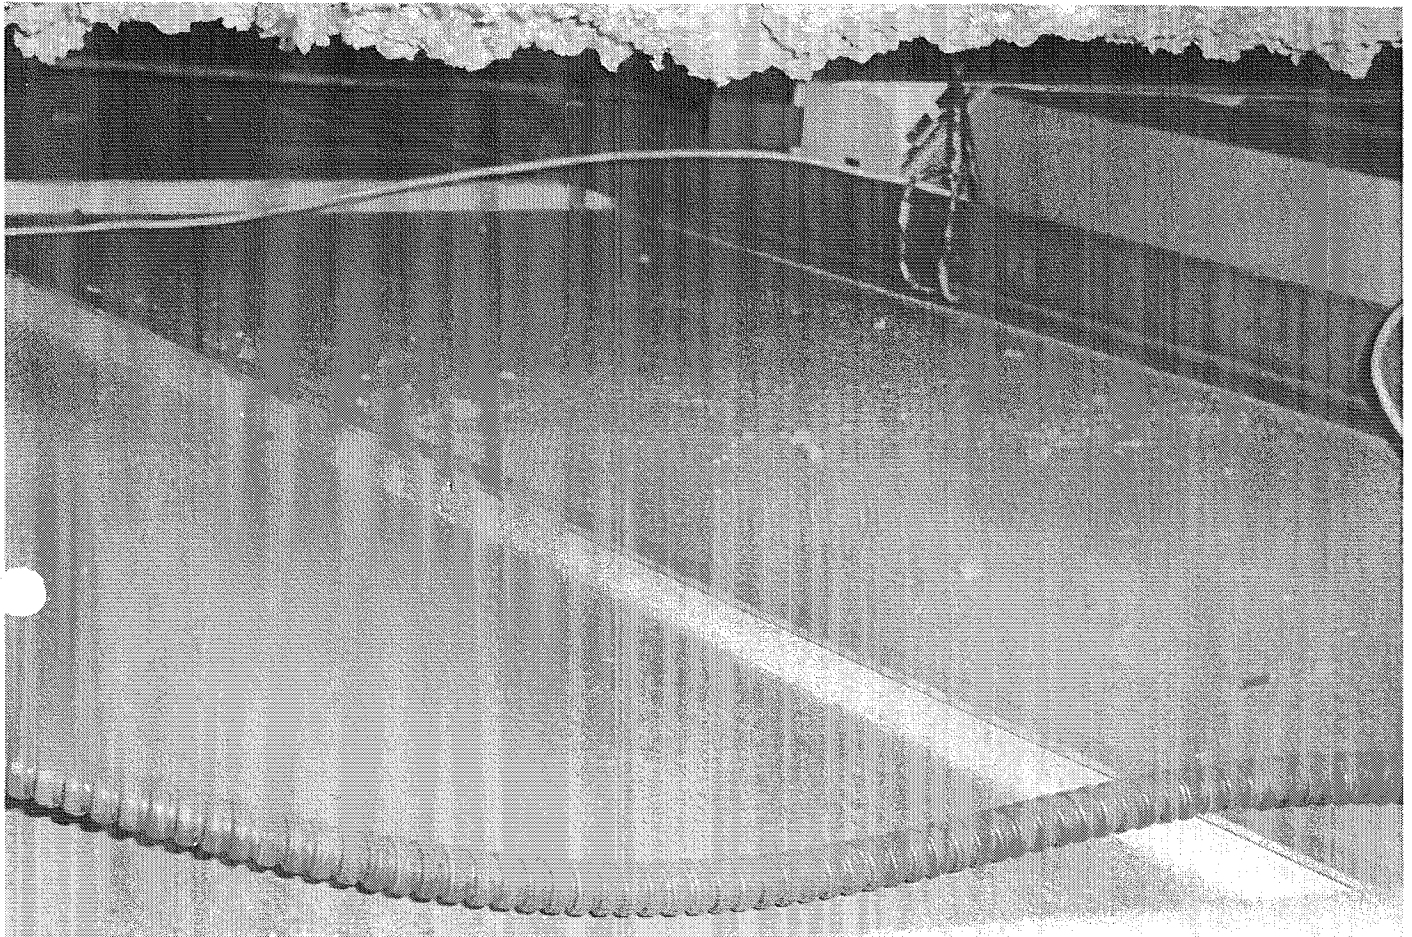
31. 21st floor, adjacent to room N2132A - View of delaminated fireproofing debris on top of suspended ceiling

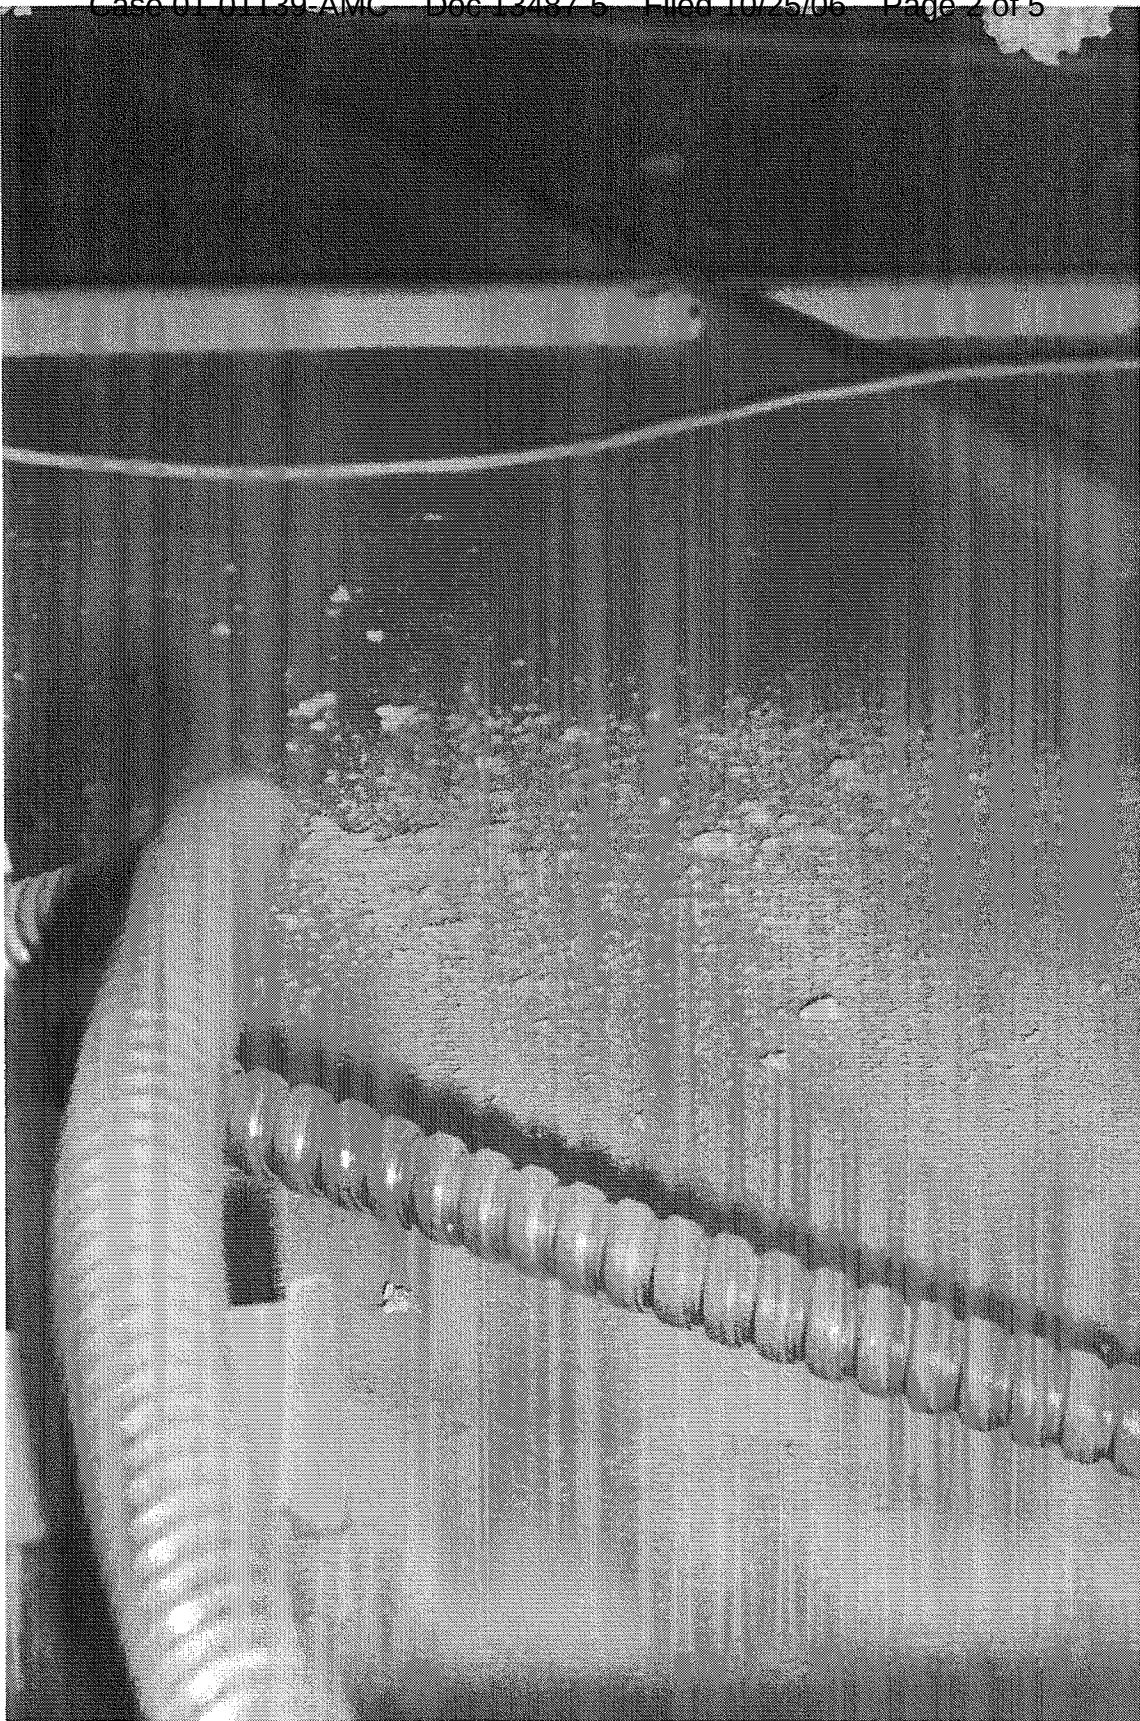
32. 21st floor, adjacent to room N2132A - Close-up of delaminated fireproofing debris on top of suspended ceiling

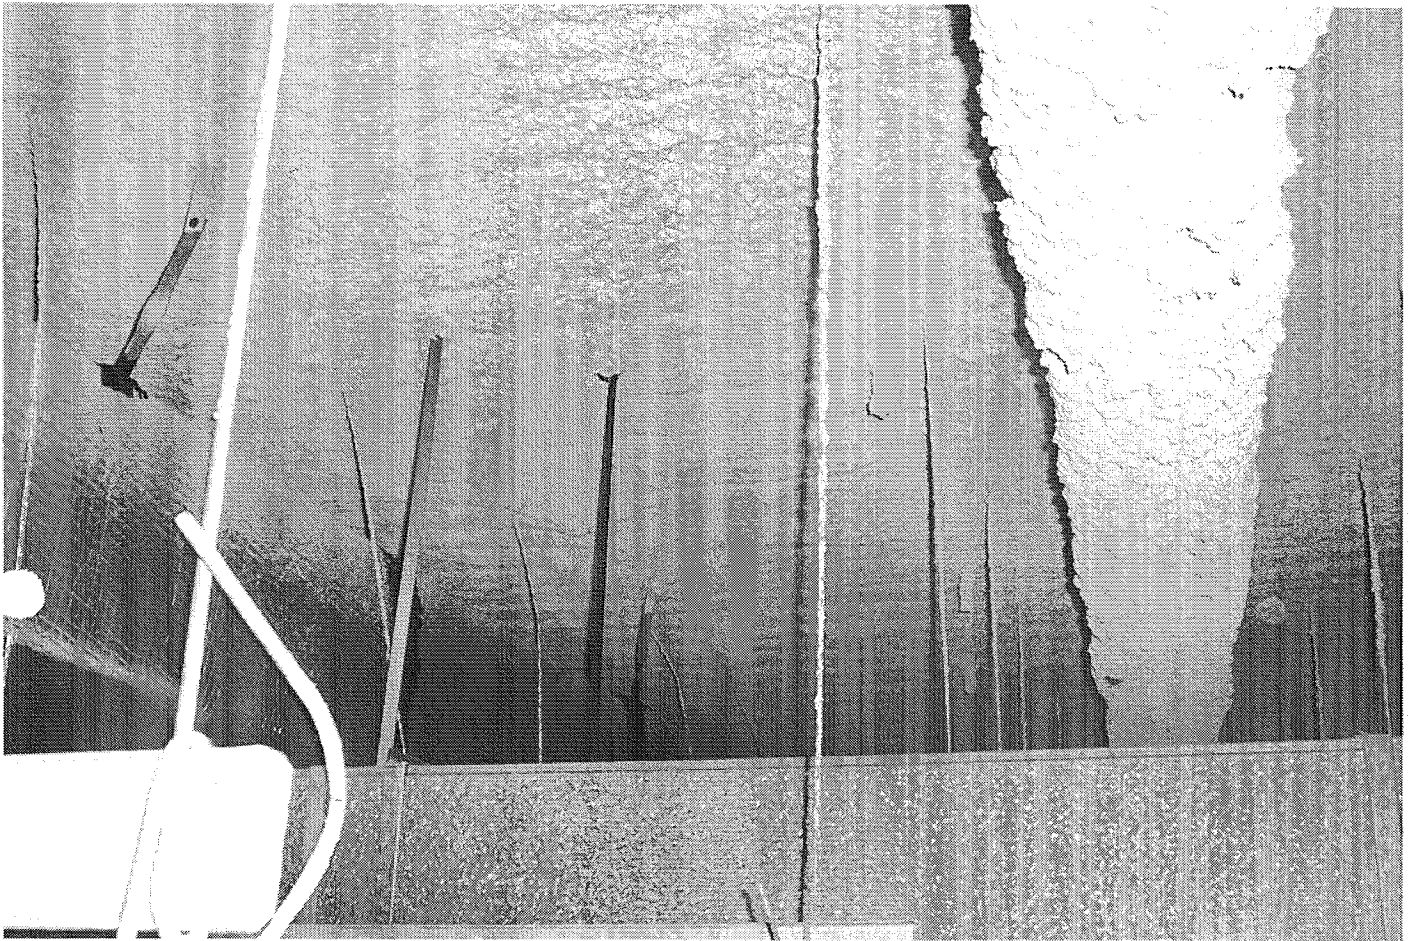
33. 21st floor, adjacent to room N2132A - General view of fireproofed sprayed beam and decking above suspended ceiling

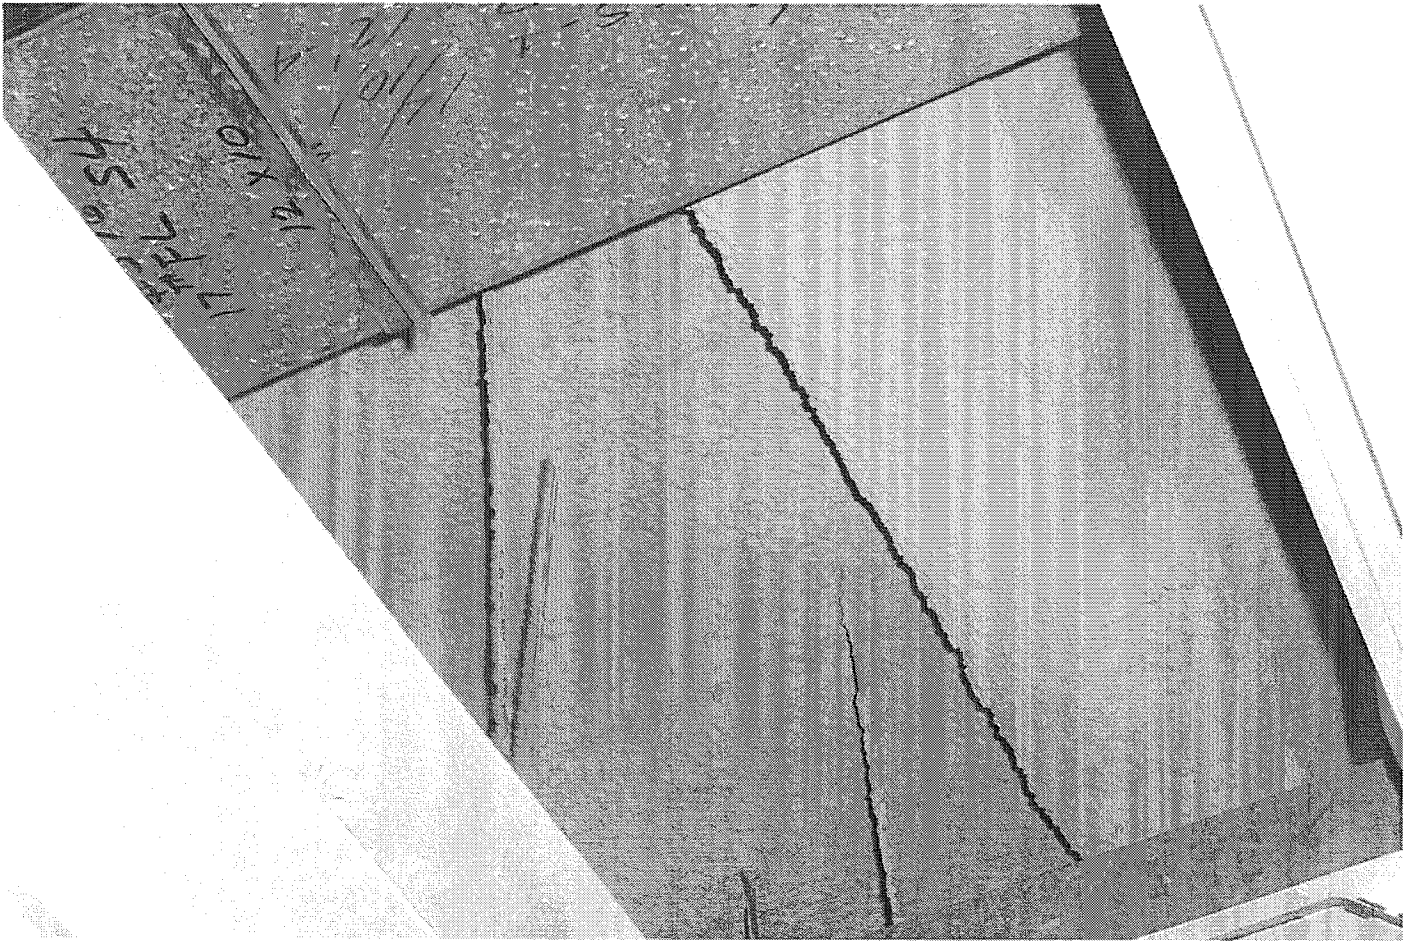
34. 17th floor, adjacent to room S1704A - General location of dust sample #3

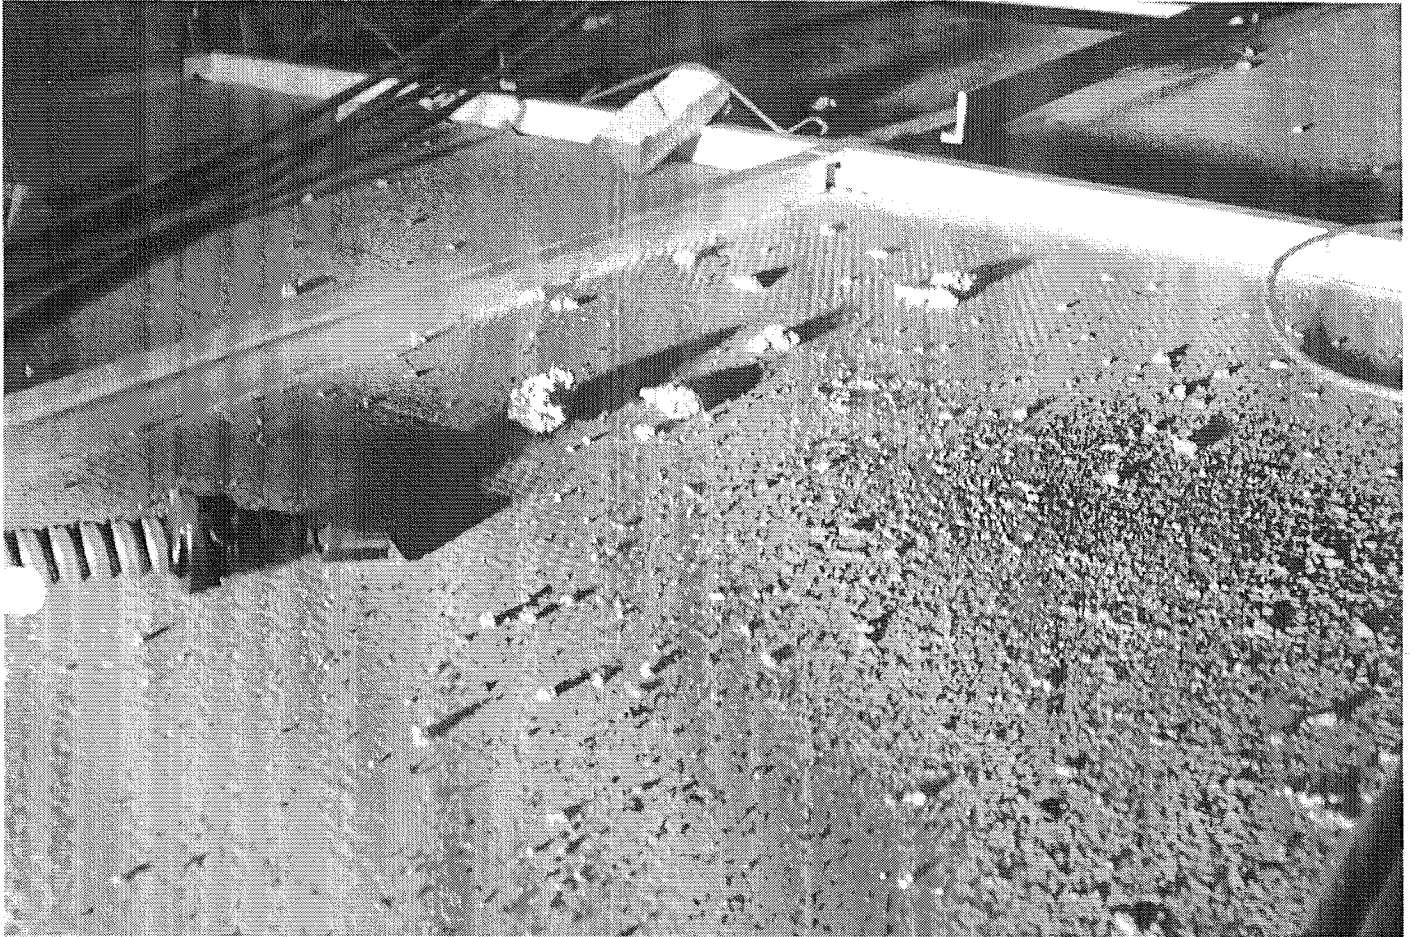
35. 17th floor, adjacent to room S1704A - View of delaminated fireproofing debris on top of suspended ceiling
